Safety Alert to IWEA member

Ejection of debris during HV fuse inspection

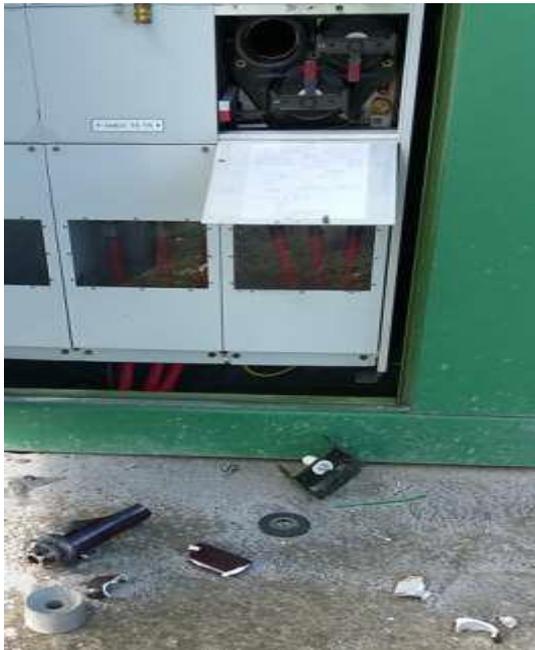
Whilst checking HV fuses under a Permit to Work (PTW) within a wind turbine package switch-fuse unit, fuse debris was ejected from a fuse chamber towards the operative causing minor burns on the neck and wrists above the gloves.

- Once the PTW as issued the site operative began the process of checking the HV fuses. Once the fuse compartment cover was opened he noticed that one of the fuse striker mechanisms had partially operated, but not tripped the switch.

- When he removed the fuse cap, the switchgear lost its SF6 gas pressure and ejected fuse debris (sand / porcelain particles) towards the operator causing minor burn on the operative's neck and wrists above his gloves.

However, it is suspected that the cause of the debris being ejected is most likely due to the blown HV fuse failing to operate the trip mechanism. This resulted in the blown fuse being heated as it sat for several hours with volts across it. This in turn heated the fuse chamber and, combined with the resultant SF6 leak into the fuse chamber, created a positive pressure behind the fuse cap.

This is the first time we have experienced debris being ejected from a switch-fuse panel and this incident is currently under investigation. Should you discover a fuse that has blown but failed to operate the trip mechanism, then before removing a fuse cap you should:

1. Allow sufficient time after the isolations are applied to allow any stored heat to dissipate.
2. The operator shall ensure there is no gap in PPE between their gloves and sleeve, and a full-face visor shall be worn.
