Safety Alert to IWEA members.

Chain failure during lifting operation of 40ft container.

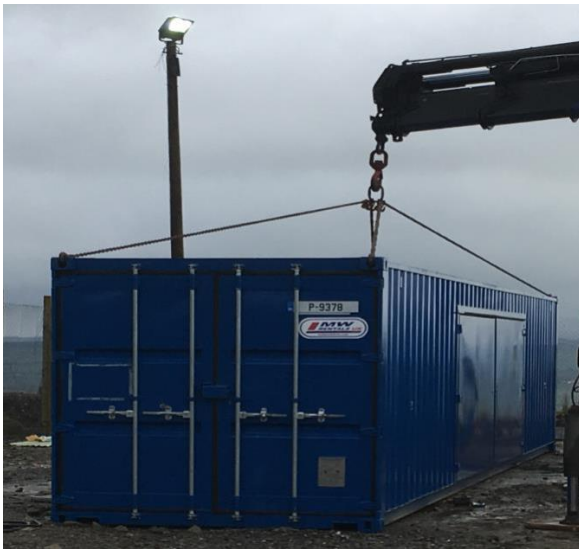
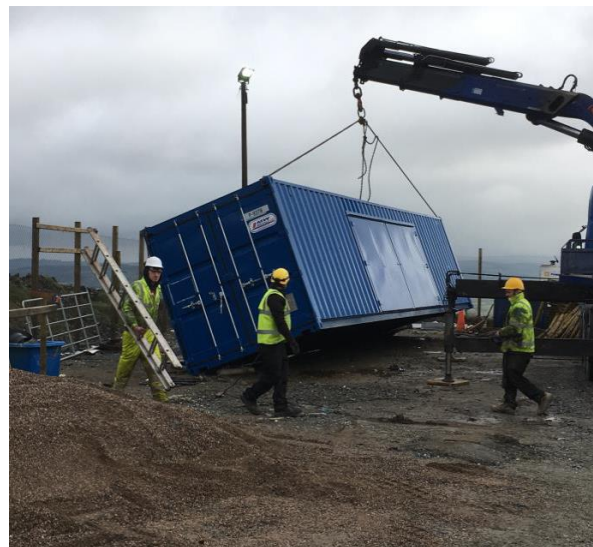
A chain failed during the lifting operation of a 40ft container. There was nobody injured in this incident.

A 40-foot container was being relocated on site. The Hiab was positioned, the chains applied and the lift commenced. The chain to the front left failed and subsequently the second chain on the right failed. The lift was stopped and the container was lowered to a safe position. The root cause of the incident is currently under investigation.

This incident reminds us all of the importance of planning **all** lifting operations on our sites not just the large turbine component lifts. Key considerations for this type of lifting operation are:

- The weight of the load and any material inside the container.
- The configuration / suitability of the chains and lifting equipment being used.
- The training and work methods of 3rd party sub-contractors / service providers .
- PSCS/PC co-ordination of small, once off lifting operations on the site.
